## FIELD INSPECTION

<b>Project Name:</b>	Mountain Valley Pipeline	<b>Inspector:</b>	Matthew Grant
<b>Inspection Date:</b>	Thursday, October 25, 2018	<b>Project Contact:</b>	Brian Clauto
<b>Spread: Montgomery County MP230-MP232 St#12153-12297</b>	Spread H	<b>Weather (Wet/Dry/Rain):</b>	Dry

## FIELD INSPECTION PHOTO LOG

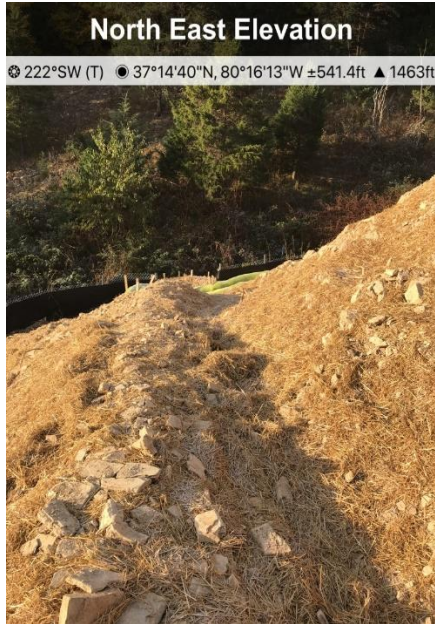
- Fig. 1 St#12158 water bar flow path requires maintenance

**Recommended Corrective Action:** replace and maintain all controls per the annual standard and specs.

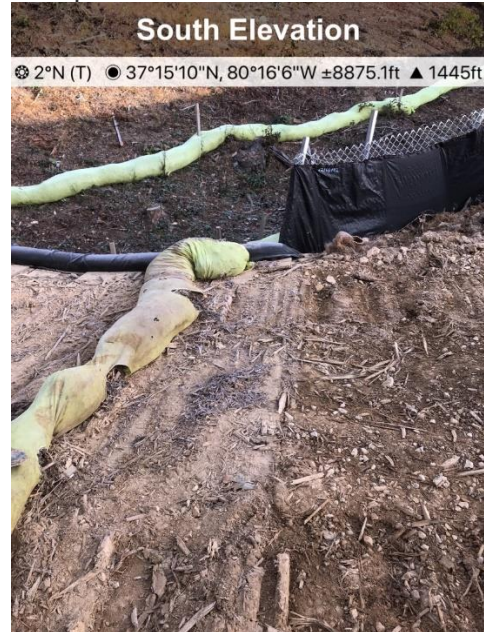
- Fig. 2 St#12167 silt sock is torn and requires replacement

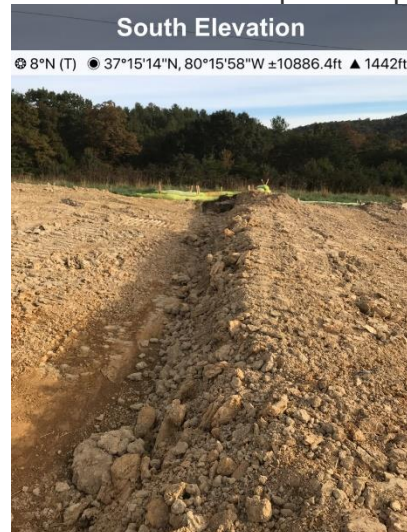
- Fig. 4 St#12185+58 waterbar requires maintenance and to be re constructed per the spec
